Building Inspection Report

1234 Wisconsin Home

Inspection Date:
10/2010

Report Number:
TD999910

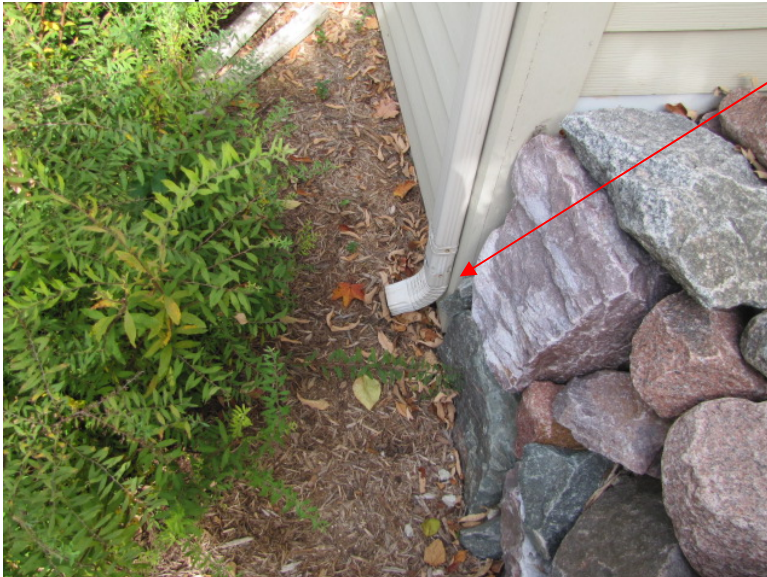
Gutters & Downspouts

- **Repair:** The downspout(s) at the front slope should discharge water at least five (5) feet from the house. Storm water should be encouraged to flow away from the building at the point of discharge.
- **Repair:** The downspout(s) at the rear slope should discharge water at least five (5) feet from the house. Storm water should be encouraged to flow away from the building at the point of discharge.

- **Repair:** Downspout(s) that discharge onto the roof at the front slope should be extended to discharge directly into the gutters below. This condition, if left unattended, can result in premature deterioration of the roofing under the end of the downspout.

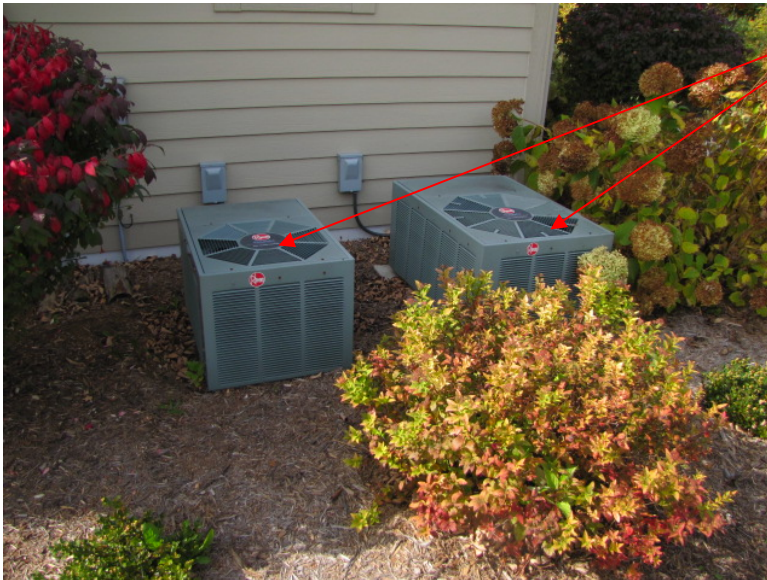
Central Air Conditioning

- **Improve:** The air conditioning system requires servicing. There were no service stickers that showed that this unit has been service in the last two years.
- **Improve:** The dirty air filter should be replaced.

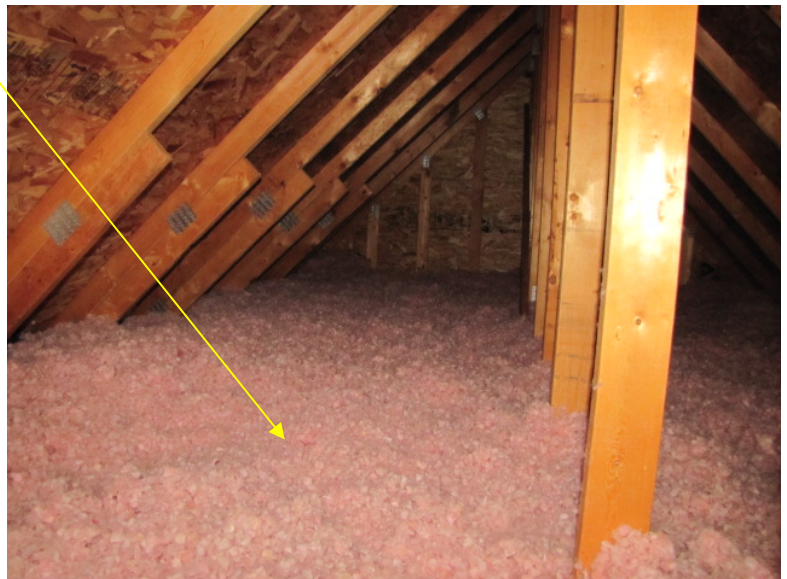
Attic / Roof

- **Repair:** There is evidence of vermin activity. A pest control specialist should be consulted in this regard.

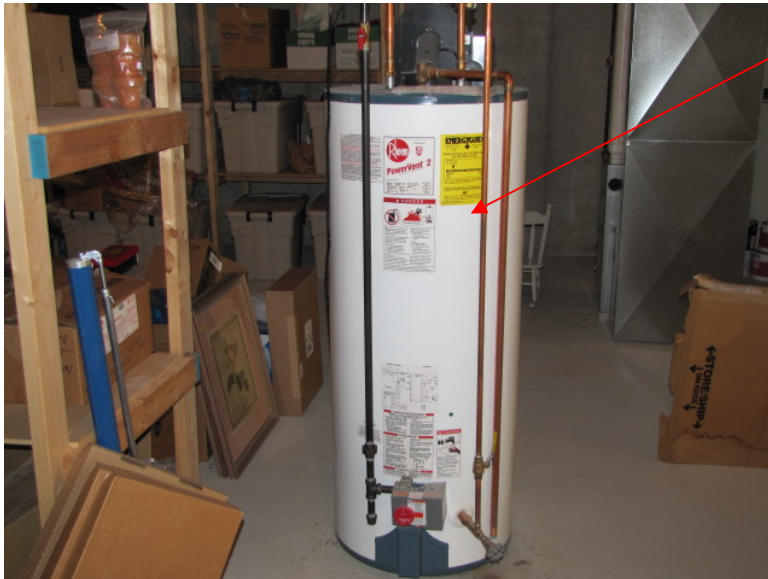
Water Heater

- **Monitor:** Water heaters have a typical life expectancy of 7 to 12 years. The existing unit is approaching this age range. One cannot predict with certainty when replacement will become necessary.

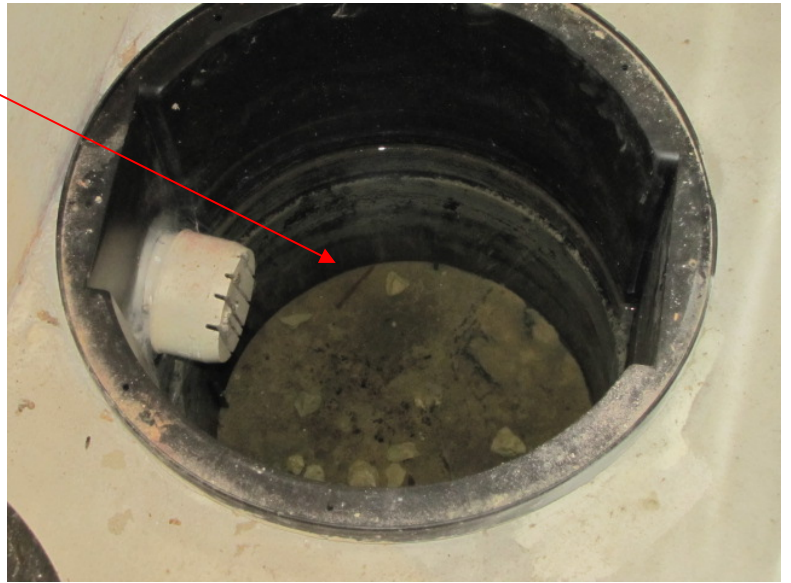
Sump Pump

- **Improve:** Sump Crock is Empty. I recommend that a sump pump be installed in the crock as there is standing water in the crock.

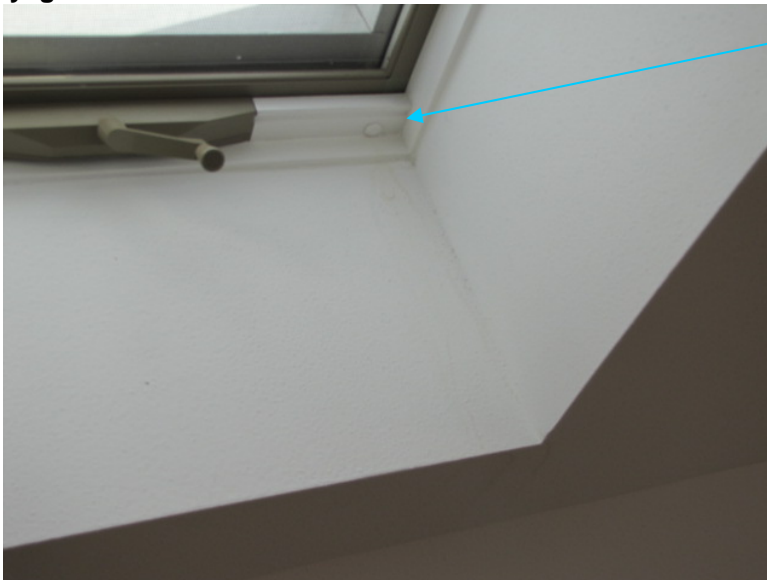
Skylights

- **Monitor:** The skylight shows evidence of condensation. This is a common condition.
- **Monitor:** No evidence of moisture penetration was visible in the basement at the time of the inspection. ***It should be understood that it is impossible to predict whether moisture penetration will pose a problem in the future.*** The vast majority of basement leakage problems are the result of insufficient control of storm water at the surface. The ground around the house should be sloped to encourage water to flow away from the foundation. Gutters and downspouts should act to collect roof water and drain the water at least five (5) feet from the foundation or into a functional storm sewer. Downspouts that are clogged or broken below grade level, or that discharge too close to the foundation are
