Building Inspection Report

1234 Wisconsin Home

Inspection Date:
10/2010

Report Number:
TD999910

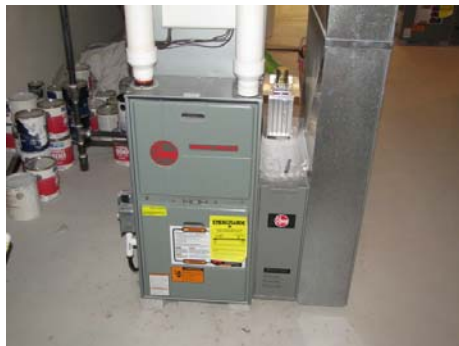
Furnace

- **Repair:** The heating system requires service. This should be a regular maintenance item to assure safe, reliable heat. There were no service stickers that showed that this unit has been service in the last two years.
